# Performance of a Polyurethane Core Seal Tested in a Hydrostatic Chamber

**Report of Investigations 9674**

**By Dennis R. Dolinar, Michael J. Sapko, and Samuel P. Harteis**

May 2008

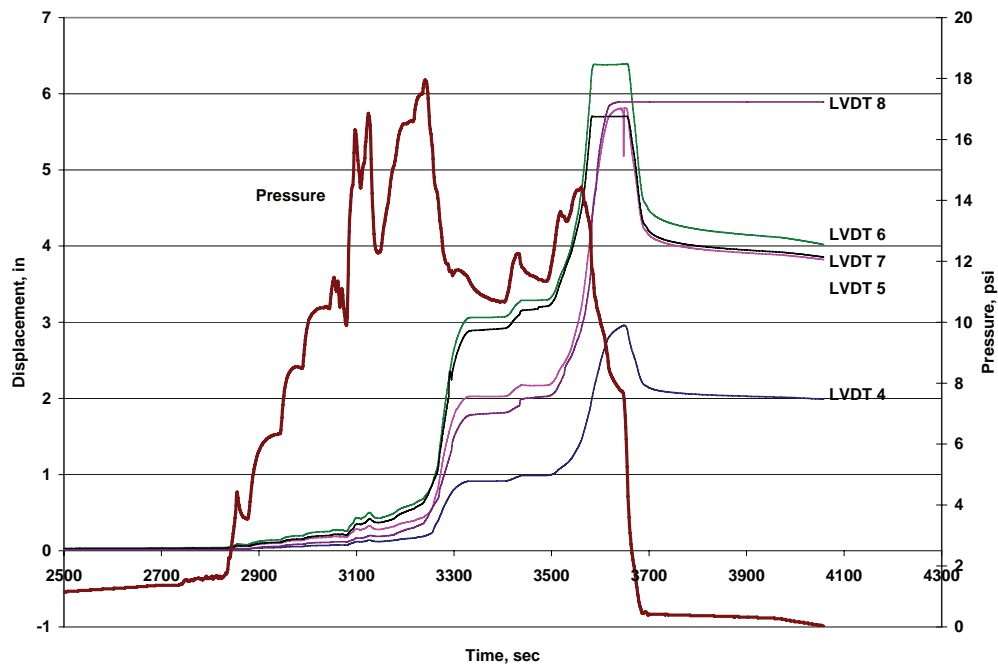
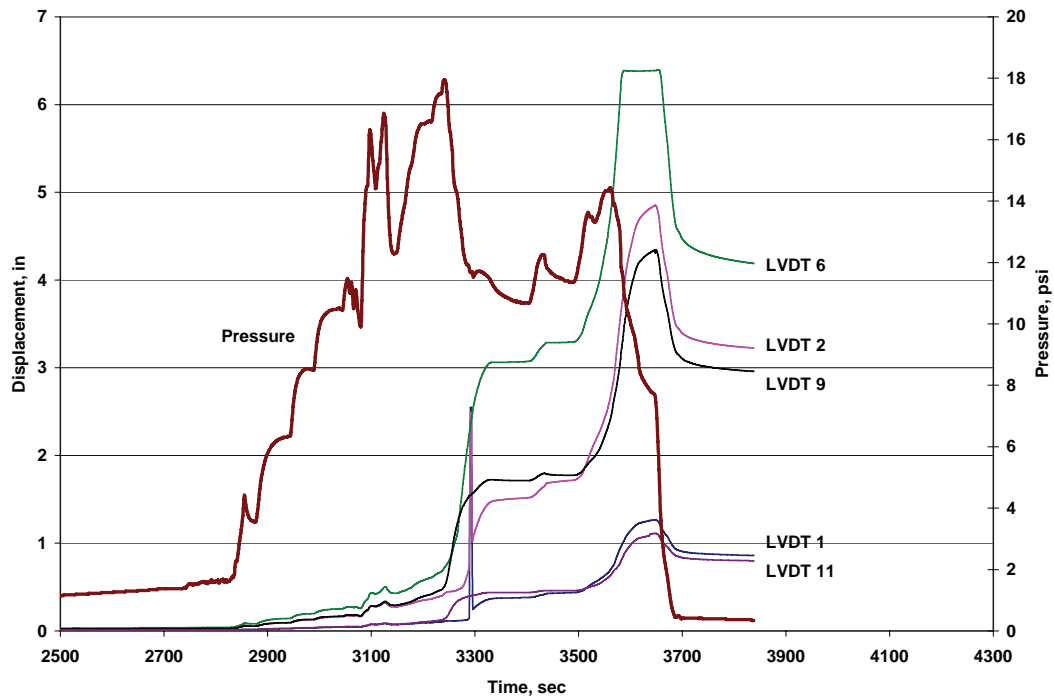
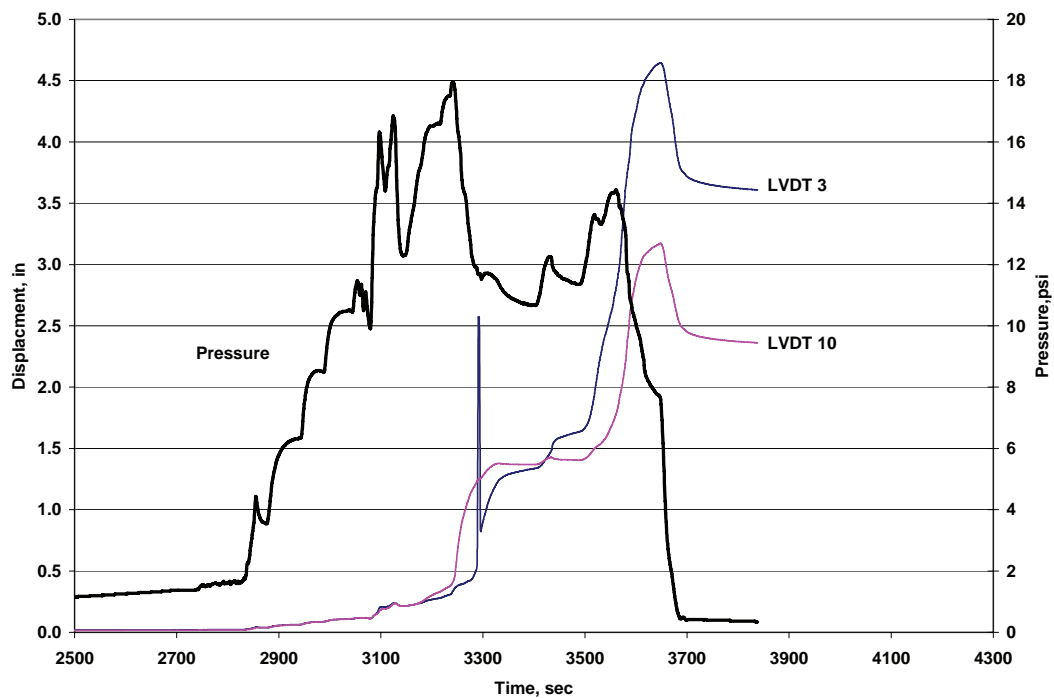
Figure 10 shows the pressure and the displacements with respect to time for the five LVDTs placed along the vertical center line of the seal. The responses of the LVDTs along the horizontal center line are shown in Figure 11, and the responses of the two LVDTs just off the horizontal center line are shown in Figure 12. During the initial pressurization to about 11 psi, the pressure-time curve showed a staircase behavior. This behavior resulted from adjustments to the rate of pressurization using a pressure relief valve at the pump. At just over 16 psi at about 3,100 sec into the test, significant leakage began to occur through the seal. This resulted in several sudden pressure drops just before reaching the maximum pressure. A maximum pressure of 18 psi at about 3,250 sec into the test was achieved at the transducer. Just past the peak pressure, a large amount of displacement occurred at all LVDT locations over a short period of time (Figures 10–12). After the maximum pressure was reached and the pressure dropped to about 11 psi because of leakage, the flow rate was increased to 800 gpm to determine if a higher pressure could be achieved. Although the pressure did increase to 14 psi with the higher pumping rate, there was an accompanying rapid increase in the seal deflection. This resulted in severe leakage from the seal and a rapid pressure drop to about 8 psi. The maximum seal deflection of at least 6 in at the center of the seal was recorded at this time. However, several of the LVDTs had reached their maximum stroke limit of 6 in. The pumping was then halted and the water was allowed to drain from behind the seal at 3,650 sec into the test. As the pressure dropped, there was some rebound of the seal with up to 2 in of displacement recovered near the center. However, there was still nearly 4 in of displacement that was not recovered by the end of monitoring.

Figure 10.—Displacement for LVDTs along the vertical center line of the seal and pressure recorded versus time.

Figure 11.—Displacement for LVDTs along the horizontal center line of the seal and pressure recorded versus time.

Figure 12.—Displacement for LVDTs just off the horizontal center line near the ends of the seal and pressure recorded versus time.

The maximum pressure that the seal withstood at the pressure transducer was 18 psi. As shown in Figures 10–12, at that point there was a large increase in displacement with a sudden drop in pressure. This occurred as the seal failed and the pumping could not keep up with the leakage. Further loading at an increased pumping rate did not achieve a higher maximum pressure, but did significantly increase the deflection and water leakage. Essentially, the 18-psi static pressure can be considered the pressure where the seal structurally failed. When this occurred, the stress was 16.9 psi at the top of the seal and 20.8 psi at the bottom. This calculates to an average stress across the seal of 18.9 psi. This is below the 20-psi criterion mandated by the Code of Federal Regulations at the time of the test [30 CFR 75 (2005)].

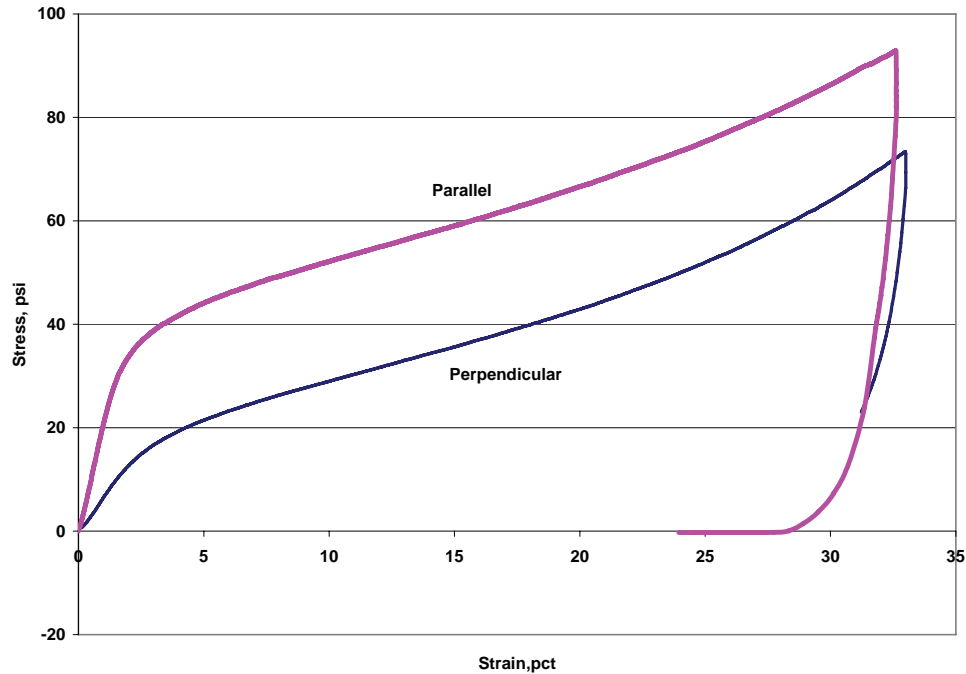
Figure 19.—Typical stress-strain curves developed from uniaxial compressive tests on polyurethane-aggregate mixture tested both perpendicular and parallel to the direction of foam rise.

The polyurethane-aggregate mixture has significantly lower compressive strengths and deformation properties than the cap with only polyurethane. The compressive strengths and elastic modulus are only about 15% of those of the polyurethane cap. This significant reduction in properties is the result of the formation of the soft foam around the aggregate. Further, there is not a sharp transition from the pre- to the postcompressive strength regions on the stress-strain curves (Figure 19).

Clearly, the formation of the soft foam is closely associated with the aggregate, as is the overall lower density of the foam in the mixture. It is assumed these changes are occurring because of residual moisture on the aggregate. The aggregate was added to provide additional mass; however, there was also a significant reduction in the compressive strength and stiffness of the polyurethane-aggregate mixture due to the addition of the aggregate. The importance of this compressive strength is that once it is exceeded, the material will exhibit nearly plastic behavior.

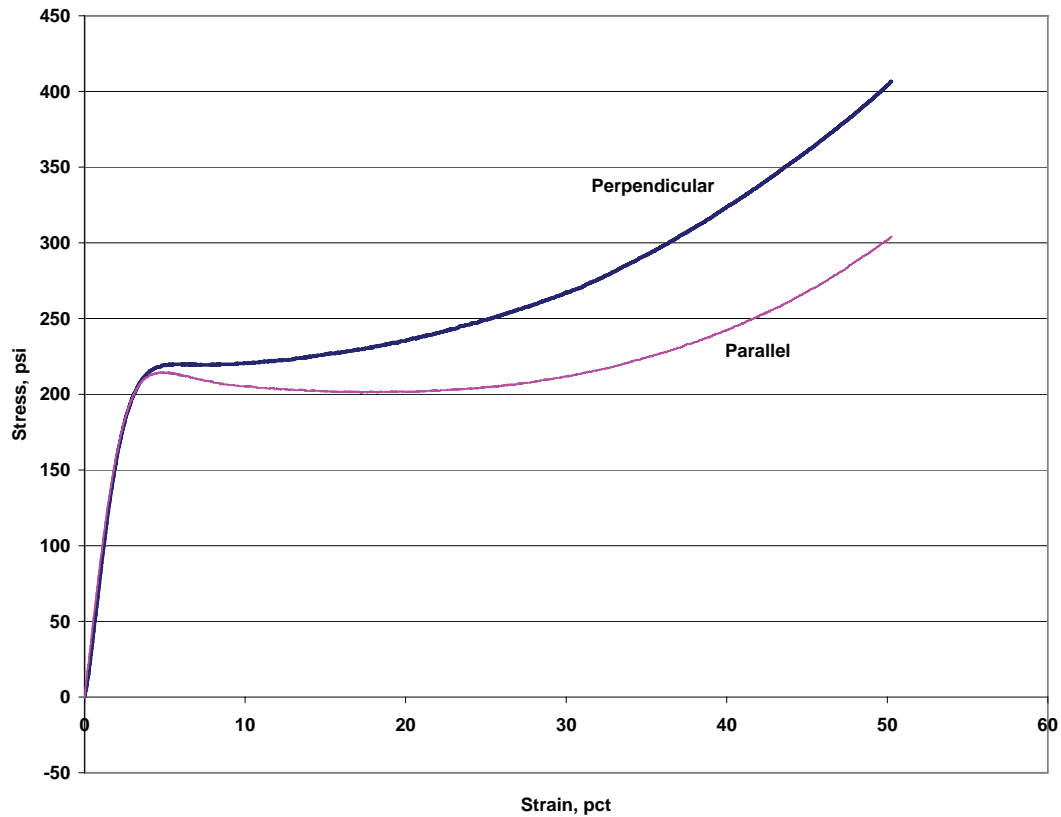
Figure 20.—Typical stress-strain curves developed from uniaxial compressive tests on polyurethane-only cap of lift.

The cap consists of polyurethane with a density of about  $11.0 \text{ lb/ft}^3$ . This does fall above the designed minimum density of  $10.0 \text{ lb/ft}^3$  for the polyurethane. In general, the stress-strain curves show the type of performance expected from rigid polyurethane foam with this density (Figure 20) [DuPont 1987; Huber and Gibson 1988; Piping Technology & Products 2008]. Initially, there is an elastic portion to the curve that is nearly linear. This is followed by a sharp flattening of the curve or even a slight drop in the stress as the foam structure collapses. Beyond the compressive strength, the stress-strain curve continues to rise, although at a much reduced rate with a nearly plastic material behavior. Further, there does not seem to be a large difference in the compressive strength between the vertical and horizontal direction. Typically, the collapse or compressive strength may be 30%–50% lower in the direction perpendicular to foam rise [Huber and Gibson 1988]. This anisotropic behavior results from a polyurethane cell structure that is more elongated in the direction of foam rise. In this case, the compressive strength is about 14% higher in the direction considered to be perpendicular to foam rise. The strength properties indicate either that the aspect ratio of the cells is close to one, where there is no cell elongation, or the orientation of the cell structure is not vertical and horizontal [Hawkins et al. 2005]. At the top of a lift, the foam that forms the cap will be free to expand not only in the vertical direction, but also in the horizontal direction, which could result in a variation of the orientation of the cell structure.

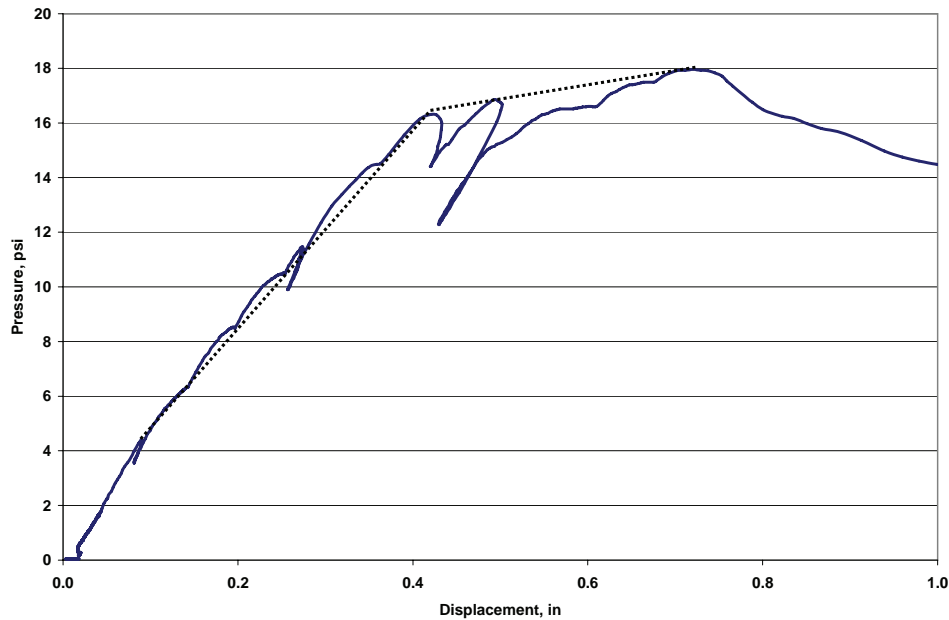
Figure 21 shows the pressure-displacement curve for LVDT 6 located at the center of the seal. The pressure used is that at the pressure transducer. From 0 to 4 psi, the curve is linear, indicating a linear elastic behavior for the seal. From 4 to 16 psi, the curve shows some nonlinear characteristics, possibly associated with inelastic behavior that is time-dependent. Fitting a line from 4 to 16 psi, the decrease in slope indicates some softening of the seal. However, from 16 to 18 psi a significant change in behavior occurs. This was accompanied by a larger increase in visible leakage from the seal. Again, fitting a line between the pressure peak at 16 psi and the maximum pressure at 18 psi shows a further and significant softening of the seal. This suggests that structural damage to the seal was taking place after the pressure reached 16 psi at the pressure transducer. Therefore, 16 psi can be considered the yield strength for the seal. This calculates to an average pressure across the seal of about 17 psi based on the stress distribution of the hydraulic load.

**Figure 21.—Pressure-displacement curve for LVDT 6 at the center of seal shows the behavior of the seal. General slopes of curves are indicated by dashed lines.**

Based on the average pressure on the seal of 17 psi at yield and the seal surface area of 184 ft<sup>2</sup>, the total force on the seal was about 450,000 lb. With a seal thickness of 18 in and assuming no contribution from the forms, the calculated shear stress along the boundary at yield was 35.3 psi. Assuming the seal acts as a plate with simply supported edges, a center deflection at yield of 0.46 in, an elastic modulus of 828 psi for the polyurethane-aggregate mixture, and a seal thickness of 18 in, the maximum stress due to bending is 3.2 psi.<sup>9</sup> The shear stresses are an order of magnitude higher than the bending stresses. Therefore, the yielding is probably the result of the shearing stresses developed near the boundaries.

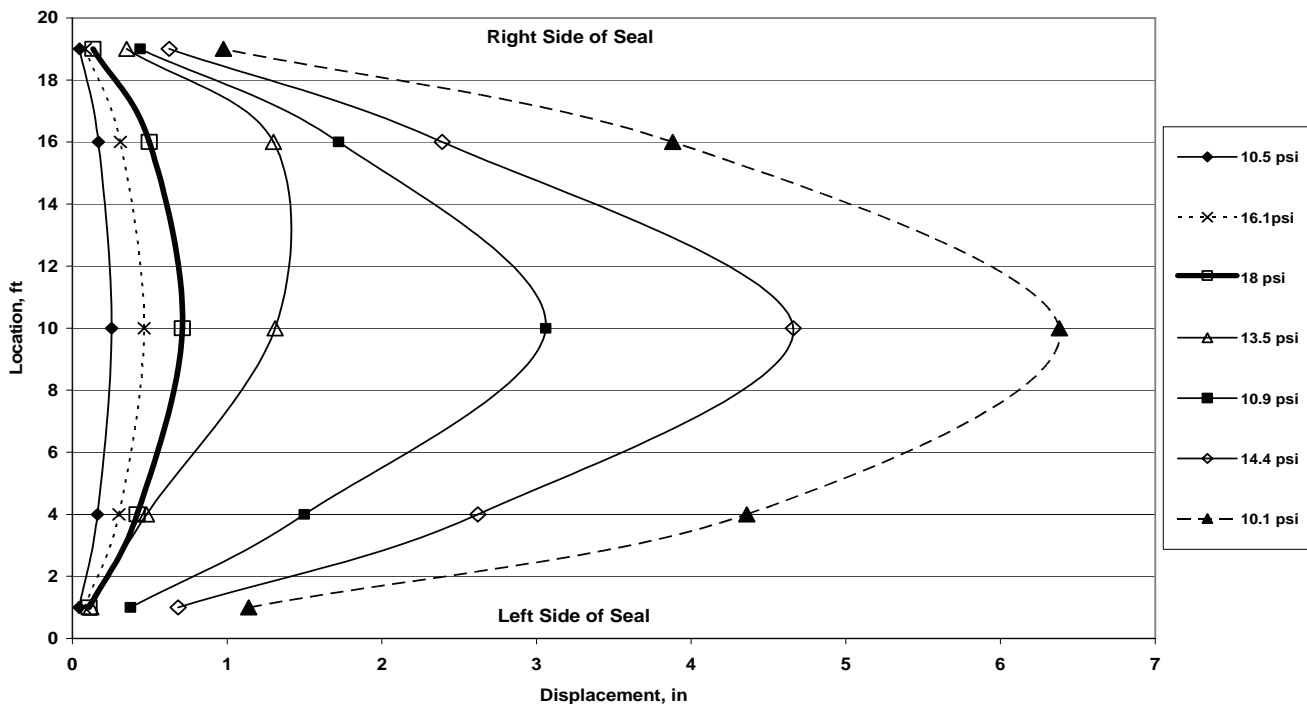
From the observed damage and the pressure and displacement measurements, an understanding of how the seal may have failed can be developed. Figure 22 shows the displacement versus the location of the LVDTs along the horizontal center line of the seal for various pressures. The lines on the graph indicate the change in shape of the seal for a given pressure. The heavy line (third from left) is the deflection at the maximum transducer pressure of 18 psi. All curves past this point are for a failed seal. At the initiation of failure, there is a change in the geometry of the seal. Failure is also indicated by the continued displacement even with a pressure drop. However, the change in shape and movement initially occurs on the right side of the seal. After the failure on the upper right side, at a pressure of 13.5 psi, the displacement at the location 6 ft to the right of the center was initially larger than the displacement at the center. Little or no additional movement is seen on the left side of the seal until the pressure has dropped to 10.9 psi. Figure 23 shows the displacement versus time for LVDTs 2 (left side), 6 (center), and 9 (right side). There is about a 40-sec delay before the increase in displacement is seen on the left side as opposed to that on the right side and center. The main damage observed along the right side of the seal is near the top where the aggregate was not well bonded with the polyurethane (Figures 13 and 17). A major leak also developed at this location (Figure 24). This high concentration of poorly bonded aggregate can be considered a construction flaw.

Figure 22.—Displacements along horizontal center line of the seal show the change in shape of the seal during the test for a given transducer pressure. Curves to the right of the 18-psi line represent the behavior after the peak pressure was achieved.

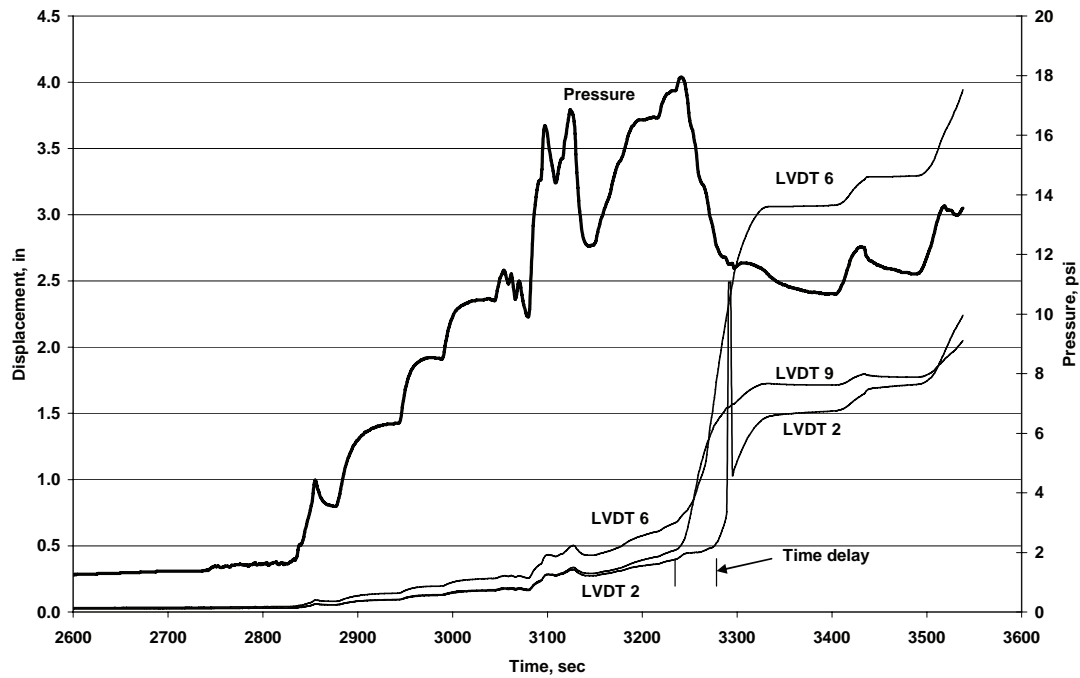
Figure 23.—Displacements measured on the left side (LVDT 2), center (LVDT 6), and right side (LVDT 9) of seal showing the 40-sec delay in the reaction of the left side when the seal failed.

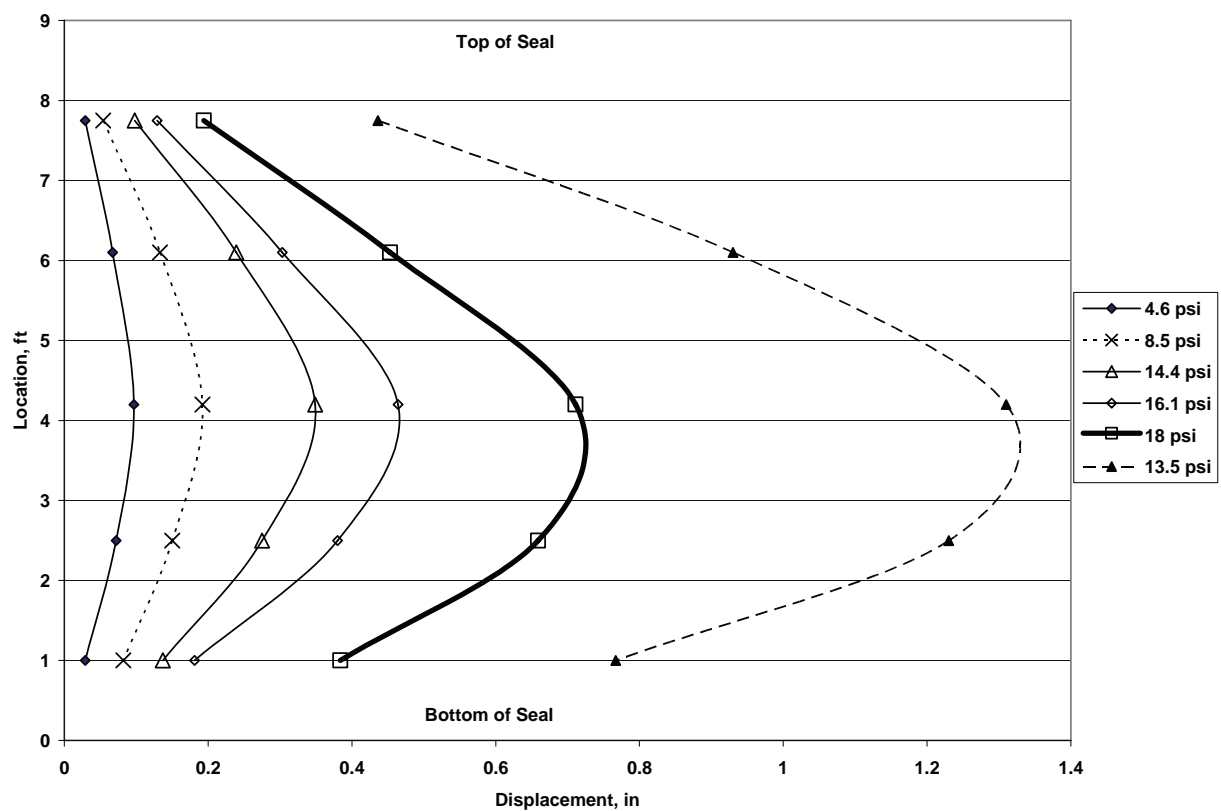
Figure 25.—Displacements along vertical center line of the seal show the change in shape of the seal during the test for a given transducer pressure. Curves to the right of the 18-psi line represent the behavior after the peak pressure was achieved.

At the lowest pressure, the fixed-end solution is closer to the actual deflections at the points away from the center (see Table 5). At the higher pressures, the simply supported solution generally calculates deflections that are somewhat closer to the measured values. The smooth arc shape of the displacement curves on Figure 25 also indicates that the seal is acting more like a simply supported beam at the higher pressures. This could occur as a result of shearing deformations that may be developing at the ends beyond that due to bending because of the low deformation properties of the seal (Figure 25).

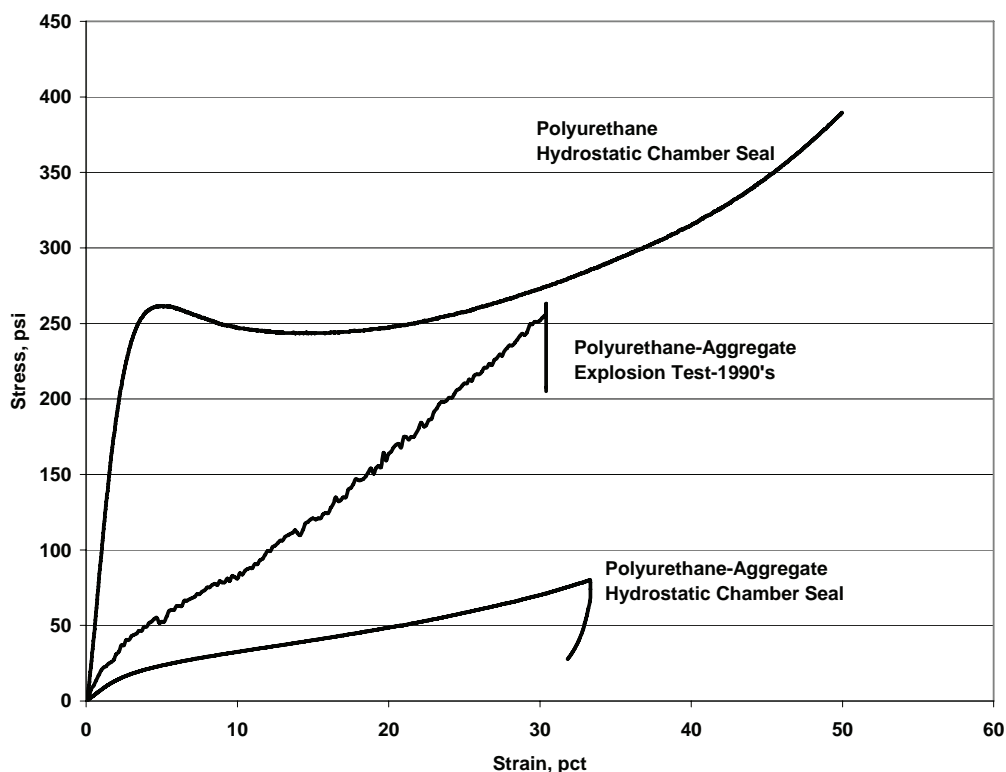
**Figure 26.—Stress-strain curves from uniaxial compressive tests on samples from explosion-tested seal from the 1990s and the seal tested in the hydrostatic chamber. Direction of testing was perpendicular to foam rise. The samples were either pure polyurethane or a polyurethane-aggregate mixture.**

The compressive test results indicate that the strength and stiffness of the polyurethane-aggregate mixture from both sets of seals were degraded significantly from those of the polyurethane only. However, the polyurethane-aggregate mixture from the explosion-tested seal from the 1990s showed much less decrease in strength and stiffness. The polyurethane aggregate from the 1990s seal has about twice the strength at 10% and 30% strain compared to the polyurethane-aggregate mixture from the more recent hydrostatically tested seal. The degradation of the strength of the polyurethane-aggregate mixture of the explosion-tested seal resulted from the formation of a small amount of soft foam around each aggregate similar to that occurring in the polyurethane-aggregate mixture from the seal tested in the hydrostatic chamber.
